CMP ISSUES

Presented by Jim Dusek, AE, Ben Ellefson, CET
 USDA-NRCS
 March 22, 2011

DAM REHABILITATION
 Replace half-round riser with full-round stop-log riser

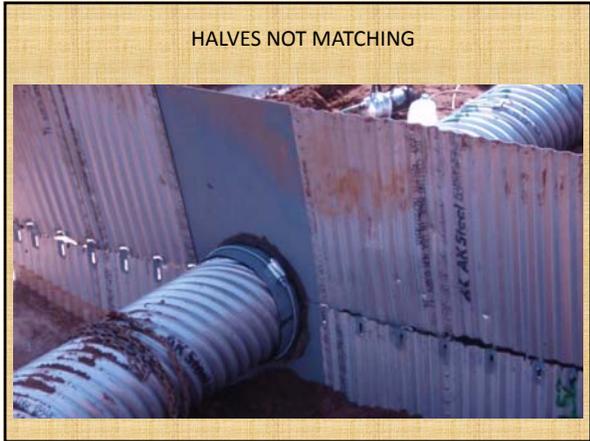
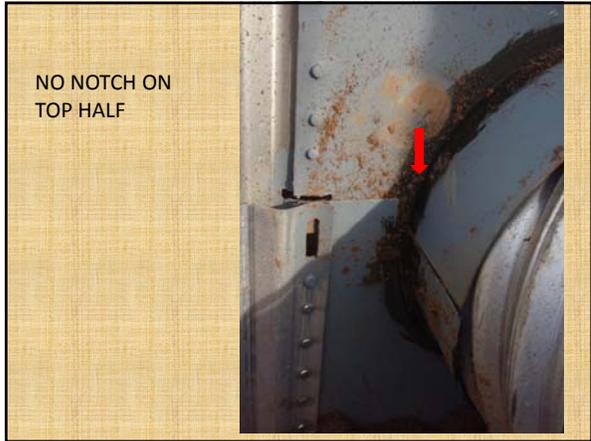
Anti-Seep Collar Issue

- Yoke – fabrication

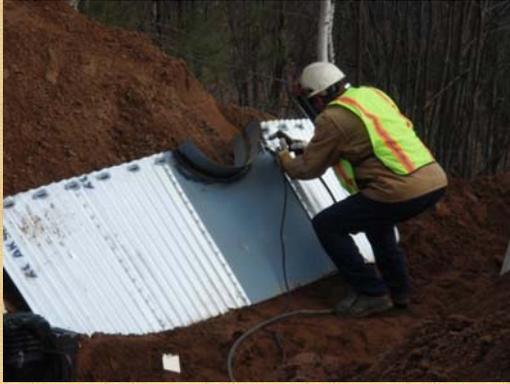
"FIELD FABRICATION" WITH PLASMA TORCH YOKE

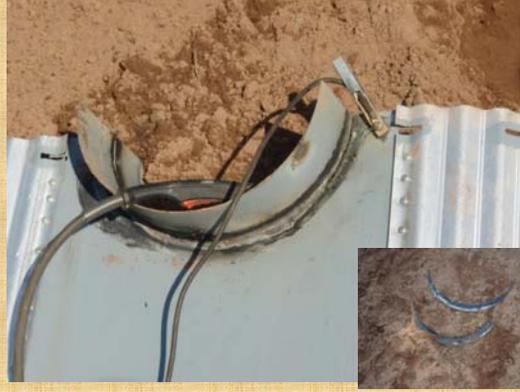
MODIFIED YOKE PLATE - POOR GROUNDING

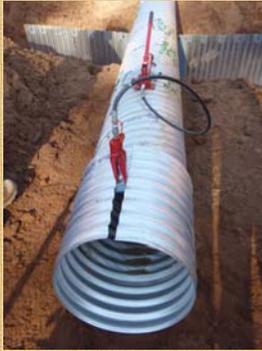
14 GA 9C BAND ON 14 GA 18 INCH PIPE
REQUIRED HYDRAULIC JACK TO INSTALL
